**Flood Control Project Maintenance  
Levee Inspections****LMA District Cover Sheet****Spring 2012 Levee Inspection Results****Levee District No. 0002 (Glenn County)**

**Levee Inspection Report By Mile - Spring 2012**

**Levee District No. 0002 (Glenn County)**

Waterway							Bank	Unit Miles	Inspection Start/End	Inspector
Unit No. 01 Glenn County Sacramento River							Right	4.89	03/21/2012 03/21/2012	Bob Duffey
LMR No.	Levee Mile		Category	Item	Location	Rating	Action/Comment	GPS Latitude/Longitude		Issue No.
	Start	End						Start	End	Photo
1			Earthen Levee	Operations & Maintenance Manuals	LS	A Ma		° °	° °	12
								DWR ID: DWR_LD0002_01_s_2012_12		
2			Earthen Levee	Emergency Supplies & Equipment	LS	A Ma		° °	° °	13
								DWR ID: DWR_LD0002_01_s_2012_13		
3			Earthen Levee	Flood Preparedness & Training	LS	A Ma		° °	° °	14
								DWR ID: DWR_LD0002_01_s_2012_14		
4	0.02	0.02	Supplemental	USACE Erosion Survey	WS	M Ma	Inspector Comments: 2009 - Very slow retreat, hard toe, encroaching into the levee projection. 2010 - Slowly eroding. 2011: Site extended downstream. [2011 Site ID: SAC_164-7_R]	39.414649 ° -122.009853 °	39.417689 ° -122.010369 °	6 Y
								DWR ID: DWR_LD0002_01

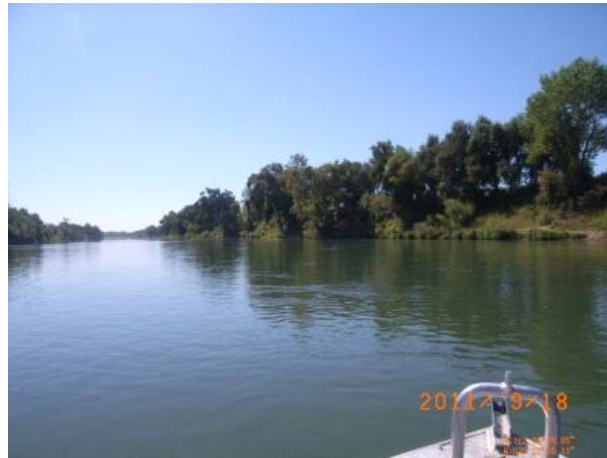
USACE 2011 Photo #1

Levee Mile Report Line	4
Start Levee Mile	0.02
End Levee Mile	0.02
Location	Water Side
Category	Supplemental
Item	USACE Erosion Survey

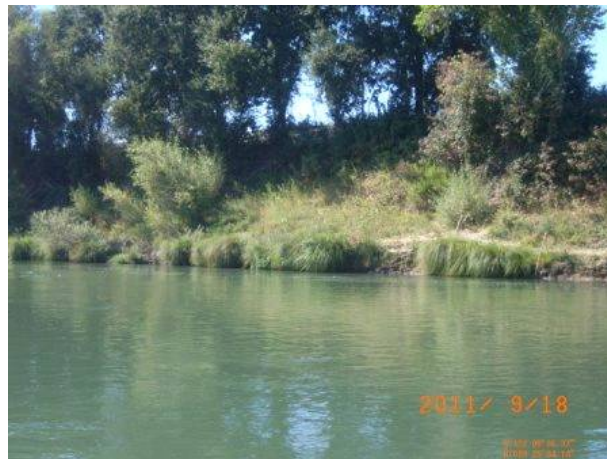
USACE 2011 Photo #2

Levee Mile Report Line	4
Start Levee Mile	0.02
End Levee Mile	0.02
Location	Water Side
Category	Supplemental
Item	USACE Erosion Survey

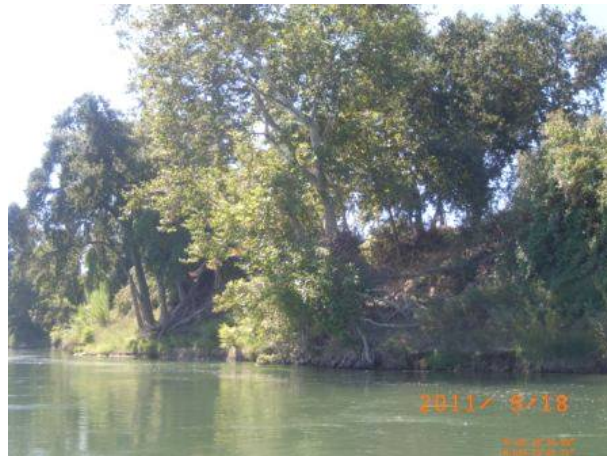
USACE 2011 Photo #3

Levee Mile Report Line	4
Start Levee Mile	0.02
End Levee Mile	0.02
Location	Water Side
Category	Supplemental
Item	USACE Erosion Survey

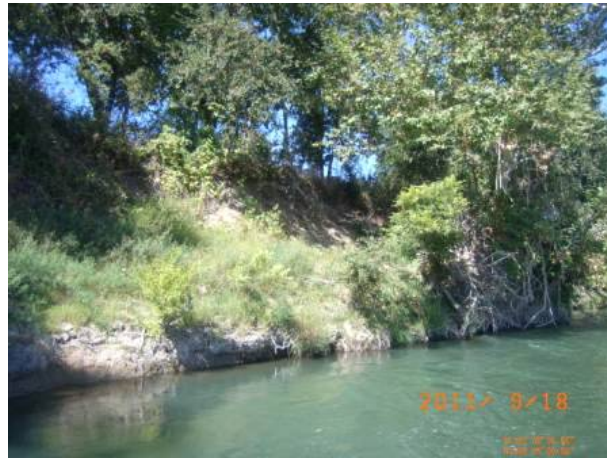
USACE 2011 Photo #4

Levee Mile Report Line	4
Start Levee Mile	0.02
End Levee Mile	0.02
Location	Water Side
Category	Supplemental
Item	USACE Erosion Survey

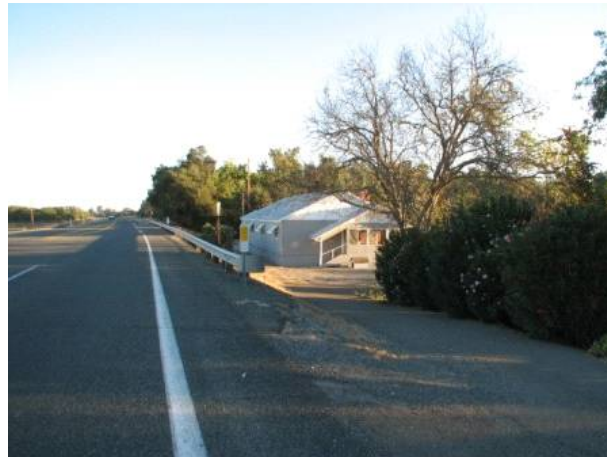
5	1.04	1.04	Earthen Levee	Encroachments	WS	M En	BU : Buildings	39.428322 ° -122.010973 °	39.428322 ° -122.010973 °	8 Y
								DWR ID: DWR_LD0002_01_s_2012_8		
6	1.09	1.09	Earthen Levee	Animal Control	WS	M Ma	A3 : No rodents visible, but rodent burrows visible; need to backfill and compact or grout burrows.	39.454387 ° -122.014835 °	39.428972 ° -122.010887 °	4 Y
								DWR ID: DWR_LD0002_01_s_2012_4		
7	1.91	1.91	Earthen Levee	Animal Control	LS	M Ma	A3 : No rodents visible, but rodent burrows visible; need to backfill and compact or grout burrows.	39.440531 ° -122.011091 °	39.440531 ° -122.011091 °	149 Y
								DWR ID: DWR_LD0002_01_s_2012_149		
8	2.95	3.00	Earthen Levee	Animal Control	LS	M Ma	A3 : No rodents visible, but rodent burrows visible; need to backfill and compact or grout burrows.	39.453595 ° -122.016273 °	39.454003 ° -122.015503 °	2
								DWR ID: DWR_LD0002_01_s_2012_2		
9	3.10	3.18	Earthen Levee	Animal Control	LS	M Ma	A3 : No rodents visible, but rodent burrows visible; need to backfill and compact or grout burrows.	39.455145 ° -122.014287 °	39.455813 ° -122.013205 °	3

Levee Mile Report Line	5
Start Levee Mile	1.04
End Levee Mile	1.04
Location	Water Side
Category	Earthen Levee
Item	Encroachments

View of house along w/s toe.

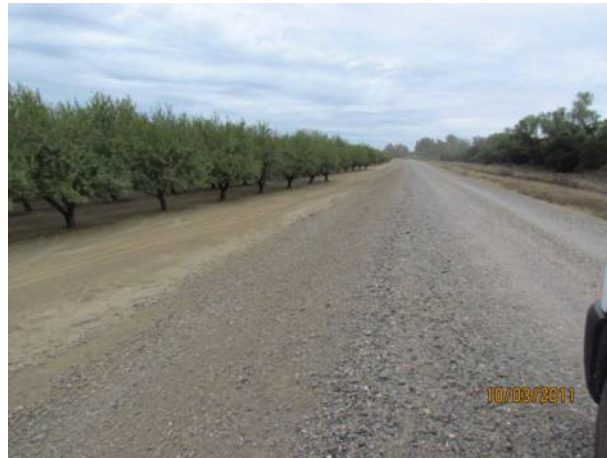
Levee Mile Report Line	7
Start Levee Mile	1.91
End Levee Mile	1.91
Location	Land Side
Category	Earthen Levee
Item	Animal Control

View of the rodent holes along the L/S slope.

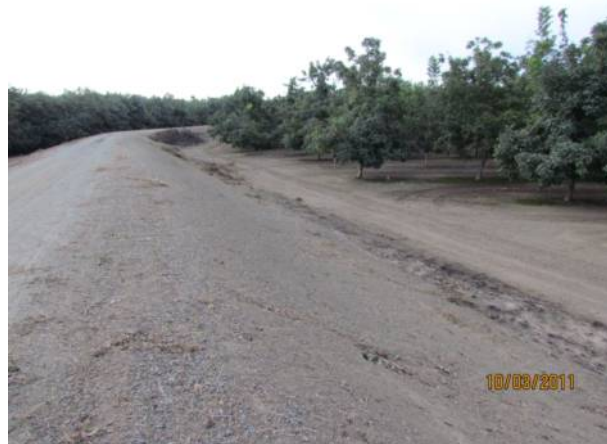
Levee Mile Report Line	10
Start Levee Mile	3.59
End Levee Mile	3.59
Location	Land Side
Category	Earthen Levee
Item	Vegetation

View of the vegetation along the L/S toe.

DWR ID: DWR_LD0002_01_s_2012_3		
10	3.59	3.59	Earthen Levee	Vegetation	LS	M Ma	V2 : Remove the wild growth other than native grasses from the levee slopes.	39.459103 ° -122.010313 °	39.459103 ° -122.010313 °	148 Y
								DWR ID: DWR_LD0002_01_s_2012_148		
11	3.61	3.61	Earthen Levee	Animal Control	LS	M Ma	A2 : Repair the levee slope damaged by livestock and prevent large animal access.	39.459348 ° -122.010500 °	39.459348 ° -122.010500 °	5 Y
								DWR ID: DWR_LD0002_01_s_2012_5		
12	3.62	3.62	Earthen Levee	Encroachments	LS	M En	PR : Prunings	39.459715 ° -122.010808 °	39.459715 ° -122.010808 °	9 Y
								DWR ID: DWR_LD0002_01_s_2012_9		
13	3.65	3.65	Earthen Levee	Slope Stability	LS	M Ma	S3 : Repair the levee slope damaged by vehicle traffic and prevent access where possible.	39.459885 ° -122.010930 °	39.459885 ° -122.010930 °	10 Y
								DWR ID: DWR_LD0002_01_s_2012_10		
14	4.87	4.87	Earthen Levee	Animal Control	LS	M Ma	A3 : No rodents visible, but rodent burrows visible; need to backfill and compact or grout burrows.	39.476676 ° -122.017439 °	39.476676 ° -122.017439 °	11 Y

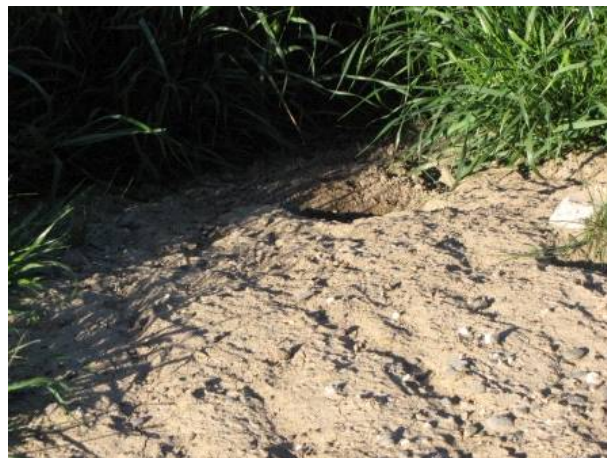
Levee Mile Report Line	11
Start Levee Mile	3.61
End Levee Mile	3.61
Location	Land Side
Category	Earthen Levee
Item	Animal Control

View of rodents burrows along L/S slope.

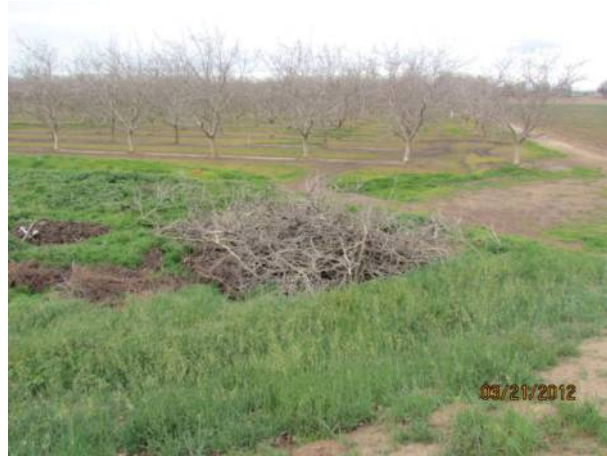
Levee Mile Report Line	12
Start Levee Mile	3.62
End Levee Mile	3.62
Location	Land Side
Category	Earthen Levee
Item	Encroachments

View of the prunings along the toe of the levee.

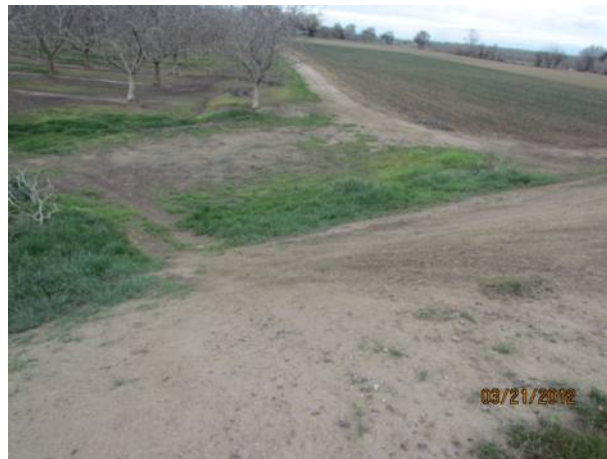
Levee Mile Report Line	13
Start Levee Mile	3.65
End Levee Mile	3.65
Location	Land Side
Category	Earthen Levee
Item	Slope Stability

View of vehicle traffic driving up and down the slope of the levee.

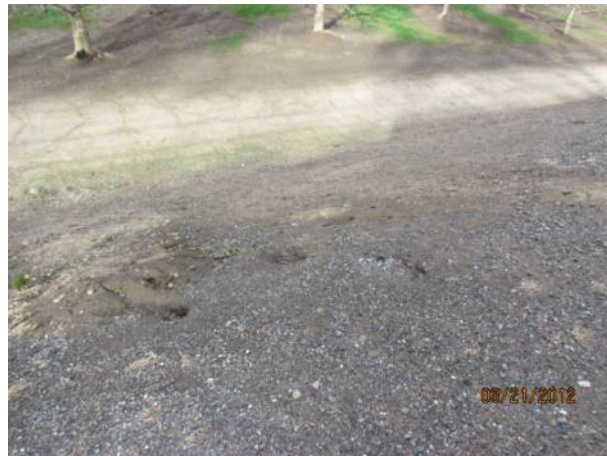
Levee Mile Report Line	14
Start Levee Mile	4.87
End Levee Mile	4.87
Location	Land Side
Category	Earthen Levee
Item	Animal Control

View of squirrel holes along the slope of the levee.
